Fort Knox Gold Mine

by Bretwood Higman, David Coil, Elizabeth Lester

Summary

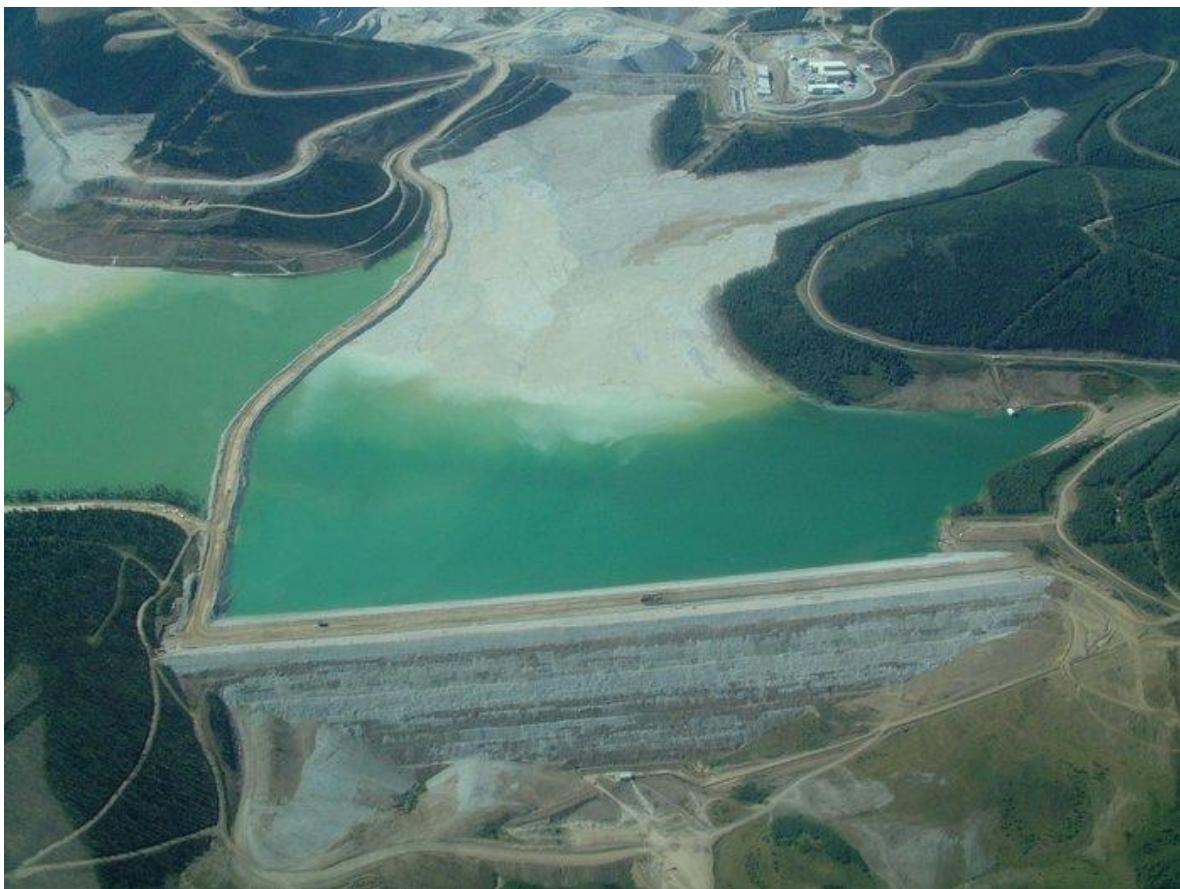
TAILINGS DAM AT FORT KNOX GOLD MINE — Mine tailings dam at [Fort Knox](#) ([/Issues/MetalsMining/FortKnoxMine.html](#)) gold mine with the mill facility in the background. — Get Photo ([/photos/tailings-dam-at-fort-knox-gold-mine/](#))
