Big Dams & Bad Choices: Two Case Studies in Human Factors and Dam Failure

by Andrew Mattox, Erin McKittrick, Bretwood Higman, David Coil

Ground Truth Trekking

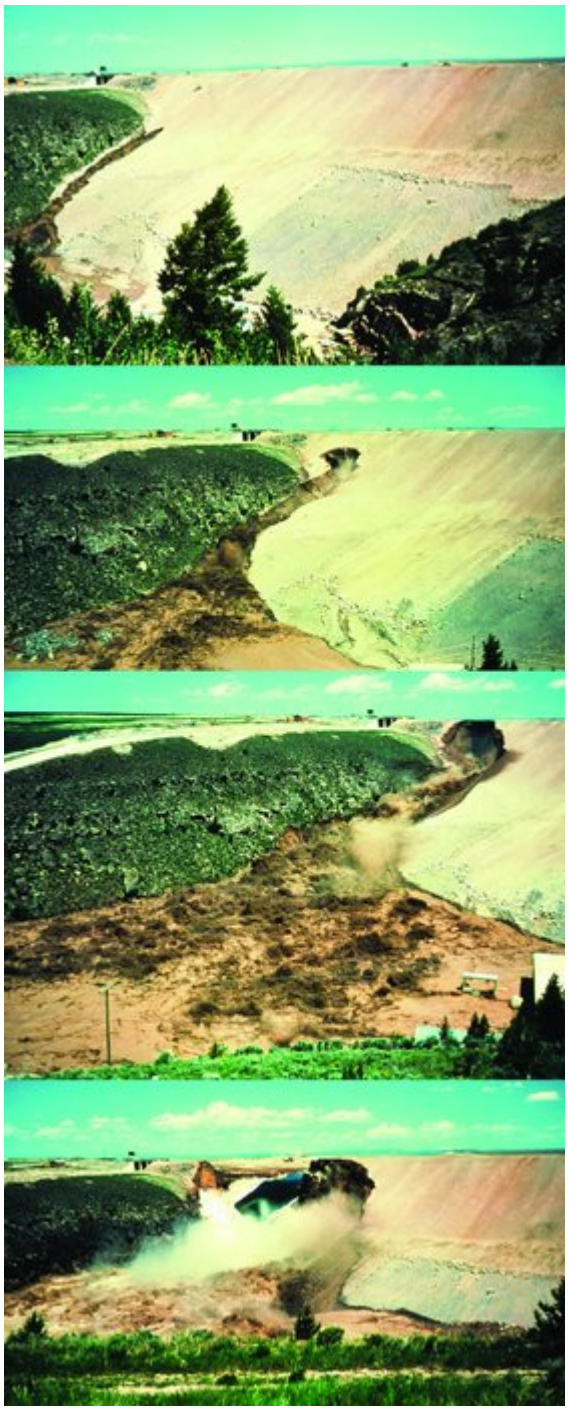
TETON DAM BREACHES — A major piping leak along the right abutment propagates headward, cutting through the crust of the dam and leading to a total breach. In the last image a tongue of “blue water” reaches through the gap. — Get Photo (/photos/teton-dam-breaches/)
