Critique of Pebble Limited Partnership's Seismic Hazard Assessment

Dr. Bretwood Higman, Ground Truth Trekking

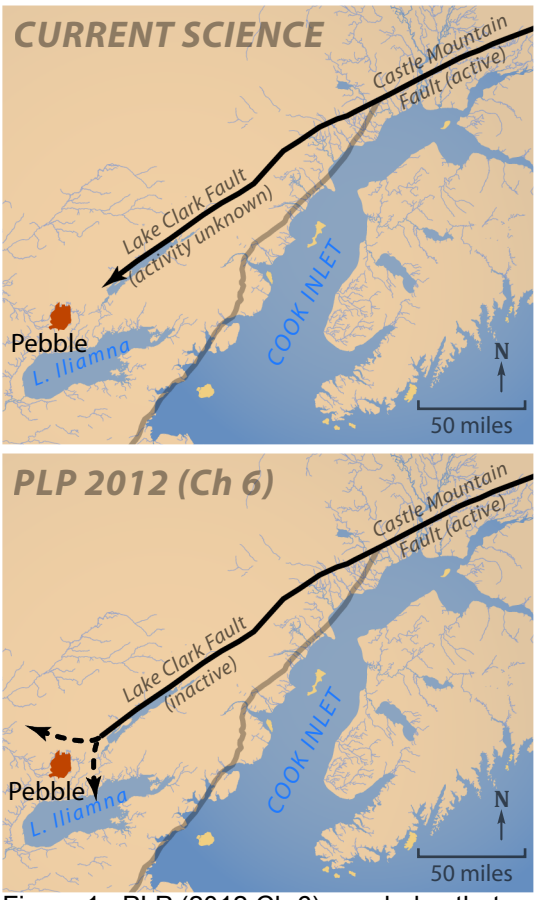
Figure 1: PLP (2012 Ch 6) concludes that the Lake Clark Fault is inactive, and veers away from the mine site. This conclusion is not supported by either PLP's work, or existing literature - the fault's location near Pebble, and its activity, are unknown.

The Lake Clark Fault is a major fault connected to the well-known Castle Mountain fault in south-central Alaska. It trends northeast to southwest, from near Beluga, through the Tlikakila River valley, and then along Lake Clark (Nelson et al., 1983). The fault has not been mapped further southwest than this. Taking the simplest assumption, that the fault continues on its mapped course, it would pass through or near the Pebble prospect (Figure 1).

Glaciers frequently cross faults, including the Lake Clark Fault further to the northeast. Many active faults are not parallel with landscape features (such as ridges and valleys) that typically control glacial flow (e.g. the Seattle Fault, Sherrod et al. 2008). For the Lake Clark Fault to track with glacial advance, it would have to make an abrupt, unusual turn (Figure 1). PLP presents no evidence that the fault actually makes this turn.

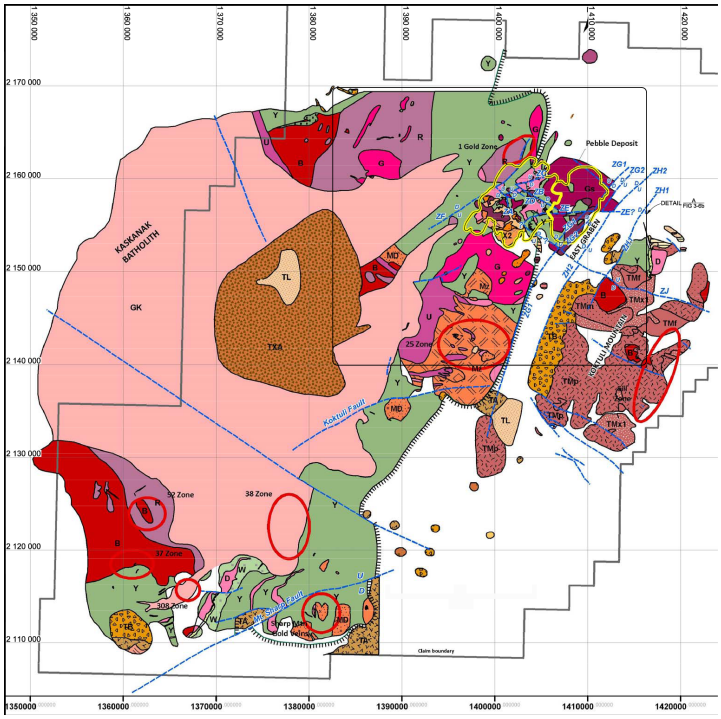
Figure 2 (PLP 2012 3.7.3, figure 3-6a): PLP maps the bedrock near Pebble Prospect. Blue lines are small faults in the area. The deposit is outlined in yellow near the northeast corner of the map.

PLP's (2012 3.7.3) geologic map (Fig. 2) shows a number of small faults cutting bedrock in the vicinity of the mine. These faults are not discussed in the PLP (2012 Ch 6) seismic hazard assessment.

PLP (2012 3.7.3) maps several parallel small faults that have allowed a wedge of bedrock to shift downward, a "graben," within the mine area. In their 2006 mine plan (DNR, 2006), a tailings dam is planned directly over this graben. This is a scenario where a fault might be activated by a human activity. Grabens form where the earth stretches, and large blocks of bedrock sink downwards along faults. Since the weight of a tailings facility would apply increased downward pressure to this graben, it has an increased chance of triggering an earthquake (McGarr et al. 2002).
