Fort Knox Gold Mine

by Bretwood Higman, David Coil, Elizabeth Lester

Summary

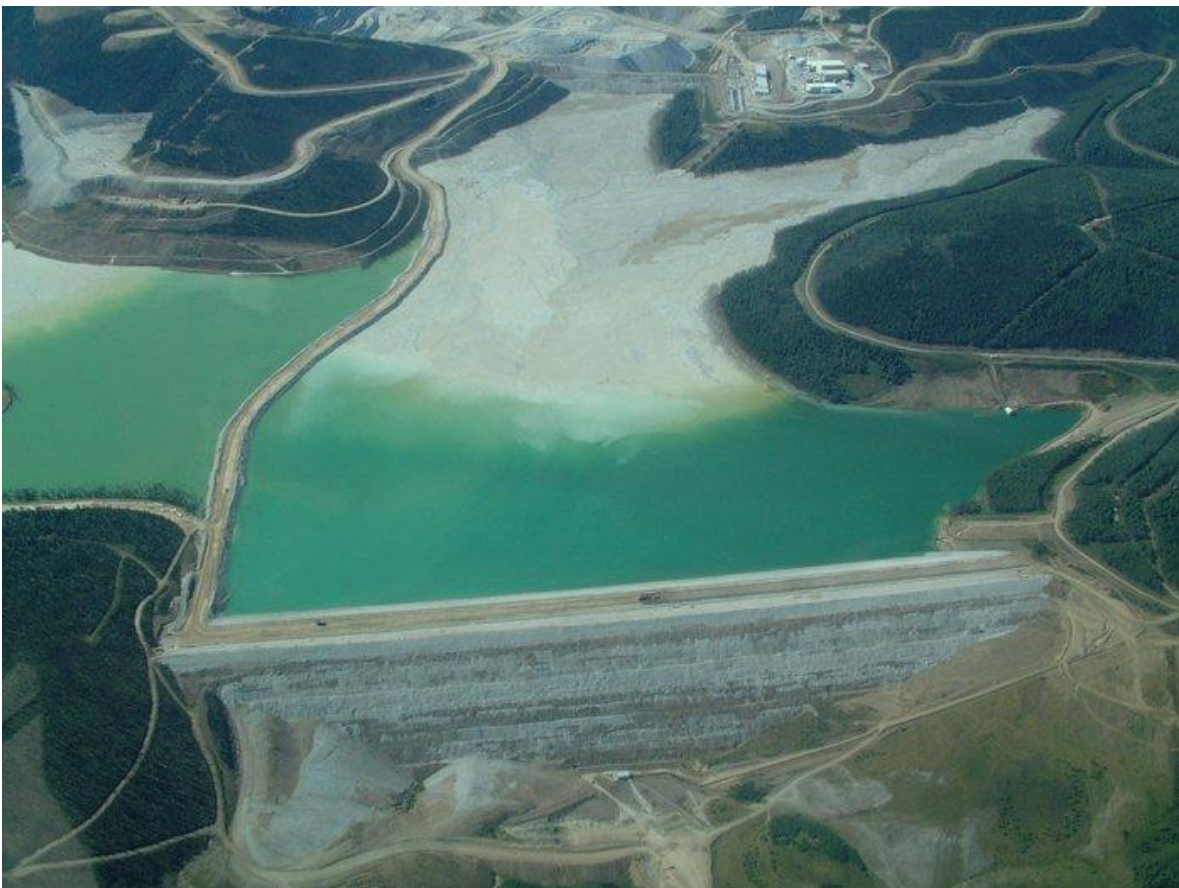
TAILINGS DAM AT FORT KNOX GOLD MINE — Mine tailings dam at [Fort Knox](/Issues/MetalsMining/FortKnoxMine.html) (</Issues/MetalsMining/FortKnoxMine.html>) gold mine with the mill facility in the background. — [Get Photo](/photos/tailings-dam-at-fort-knox-gold-mine/) (</photos/tailings-dam-at-fort-knox-gold-mine/>)
